**THE PLASTIC CLUB OF PHILADELPHIA: A SITE MANAGEMENT STUDY
AND BUILDING ANALYSIS**

A THESIS

MASTER OF SCIENCE IN HISTORIC PRESERVATION

2007

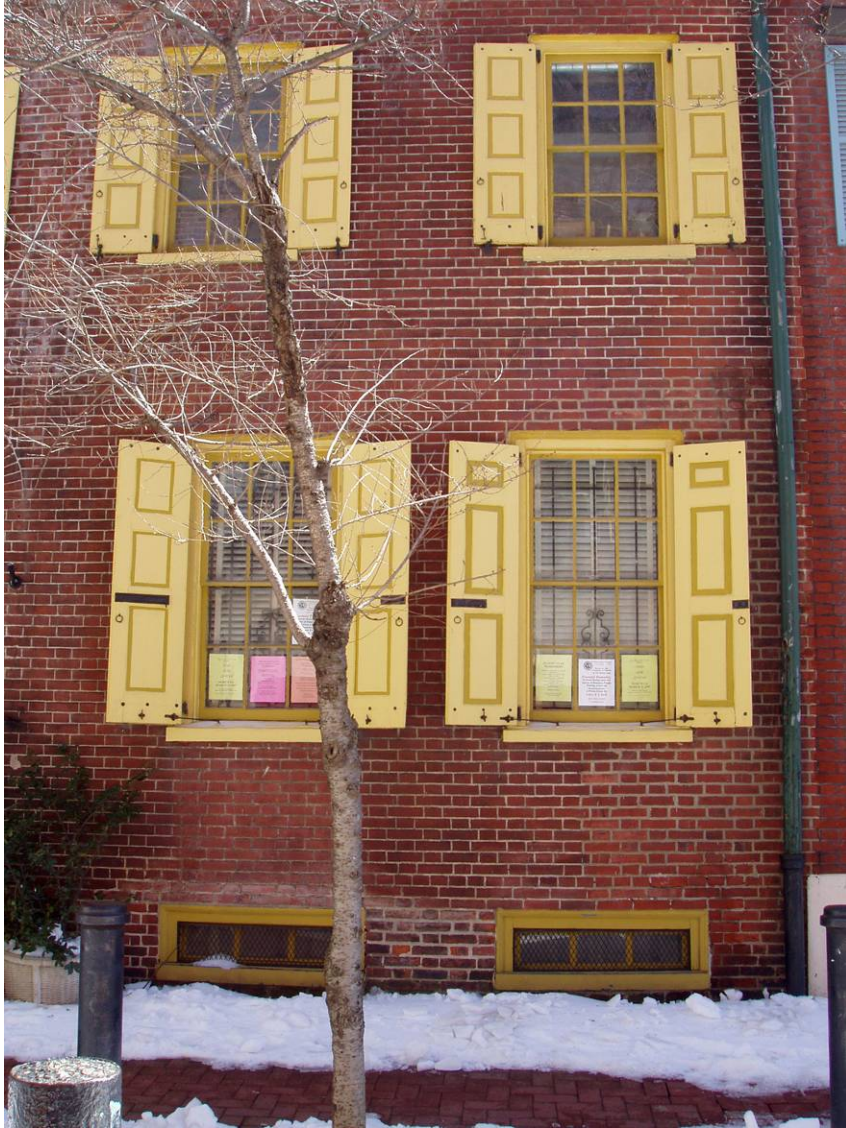
Figure B7. Exterior façade of 247 S. Camac Street, southern half (former 249 S. Camac Street). Note slight discoloration in the mortar on the right side, where the front door of 249 S. Camac Street was removed.

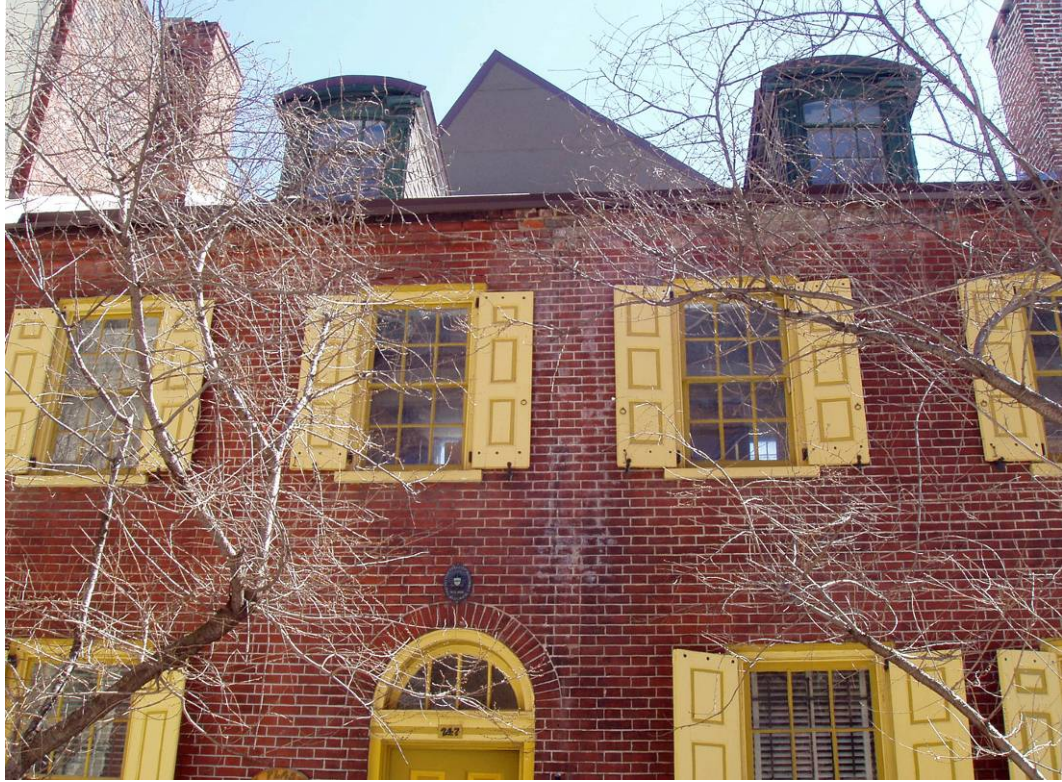
Figure B8. Exterior façade of 247 S. Camac Street, second story. Note the efflorescence on the brick between the middle windows.

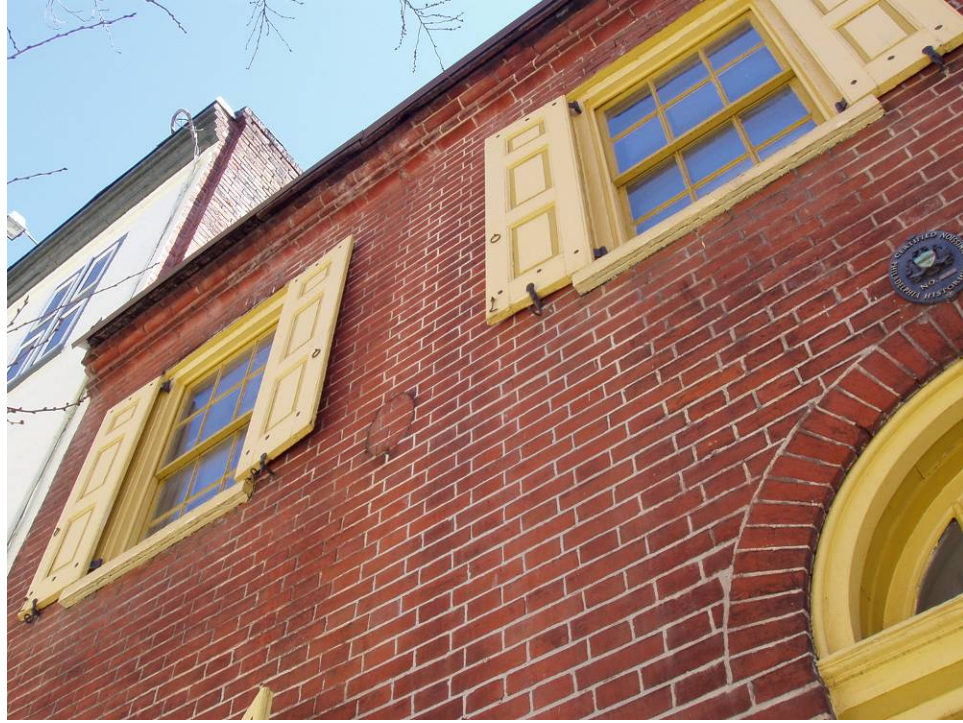
Figure B9. Exterior façade of 247 S. Camac Street, detail of the cornice and efflorescence on the brick.

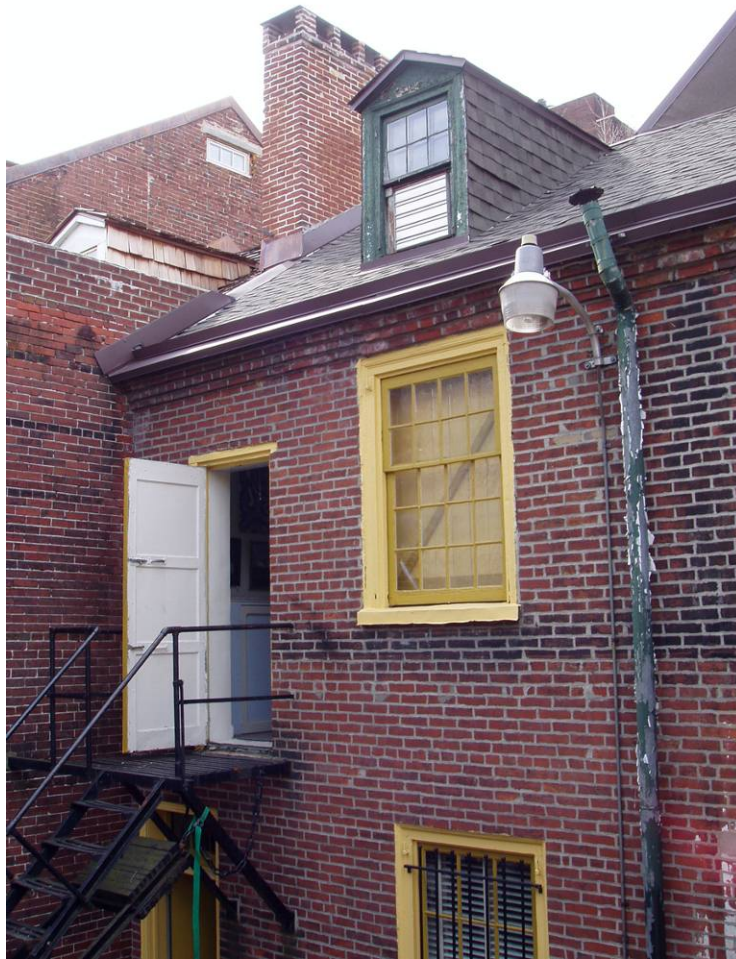
Figure B11. Rear façade, southern half. Note the poor condition of the dormer window.

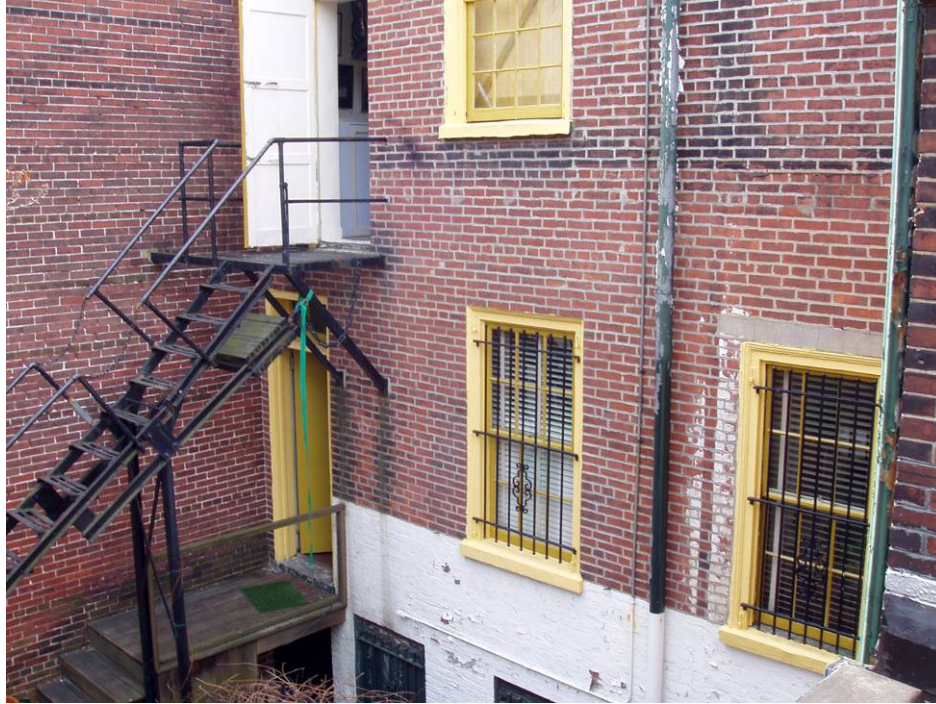
Figure B12. Rear façade, southern half. Note the rust stains on the brick below the fire escape and the peeling paint on the lower part of the wall.

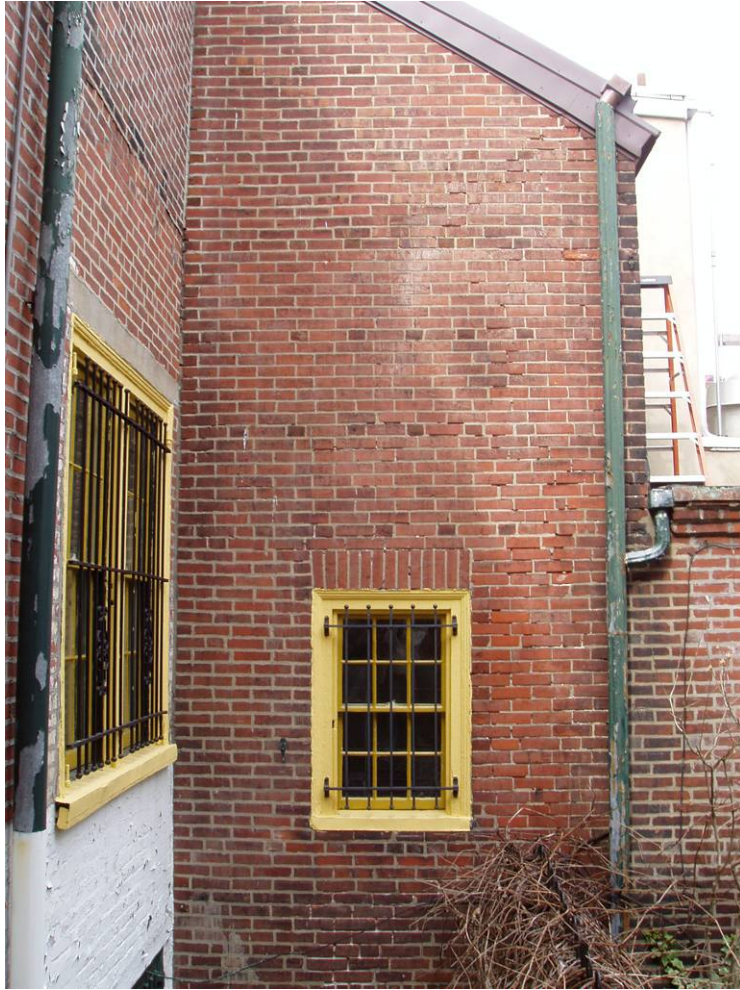
Figure B15. Rear façade, southern face of the rear stairwell extension on the north end. Note the areas of mortar loss on the wall.

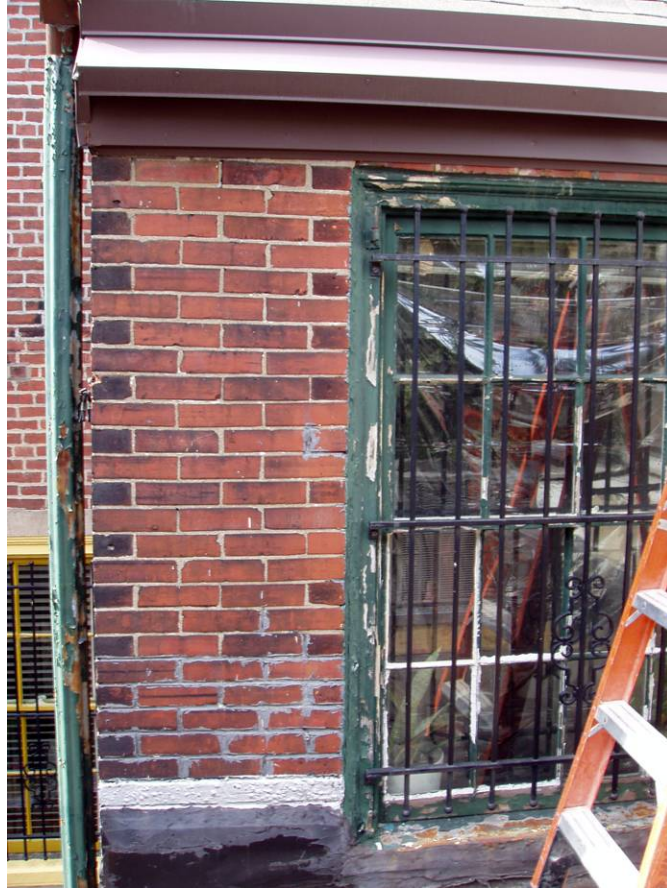
Figure B17. Rear façade of the stairwell extension, window of the landing at mid-level. Note the peeling paint and areas of decay on the wood window frame.

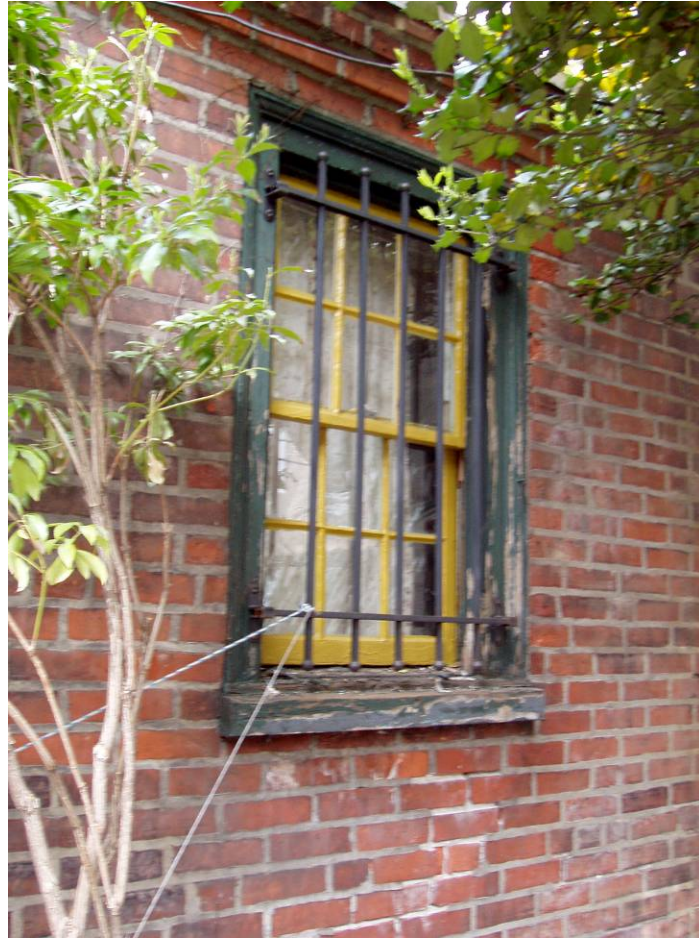
Figure B18. Rear (east-facing) window of the restroom extension. Note the paint loss and wood deterioration on the window frame.

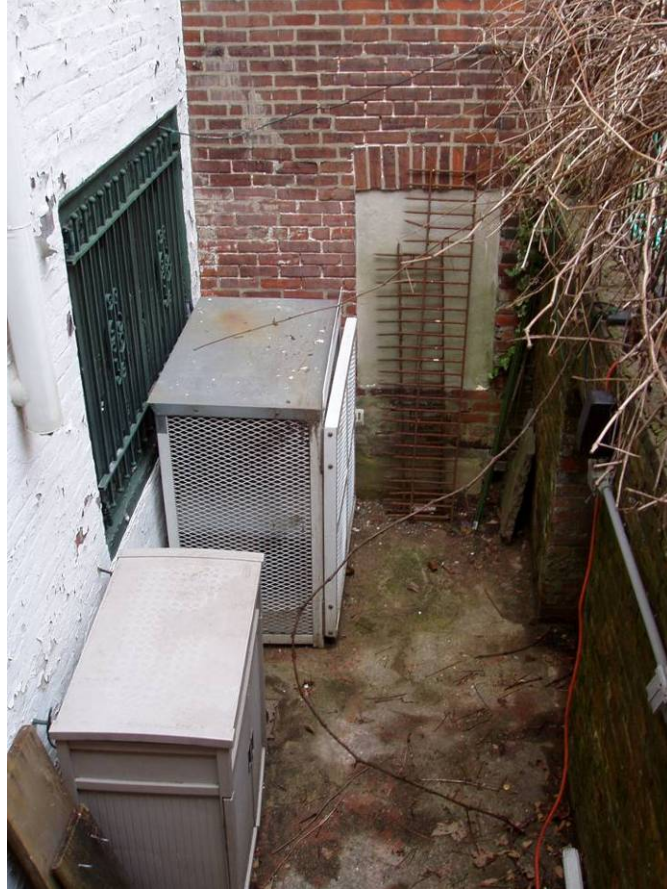
Figure B19. Rear façade, basement level passageway, looking north. Note the window to the basement restroom filled with concrete and the green biogrowth on the brick walls and concrete floor.

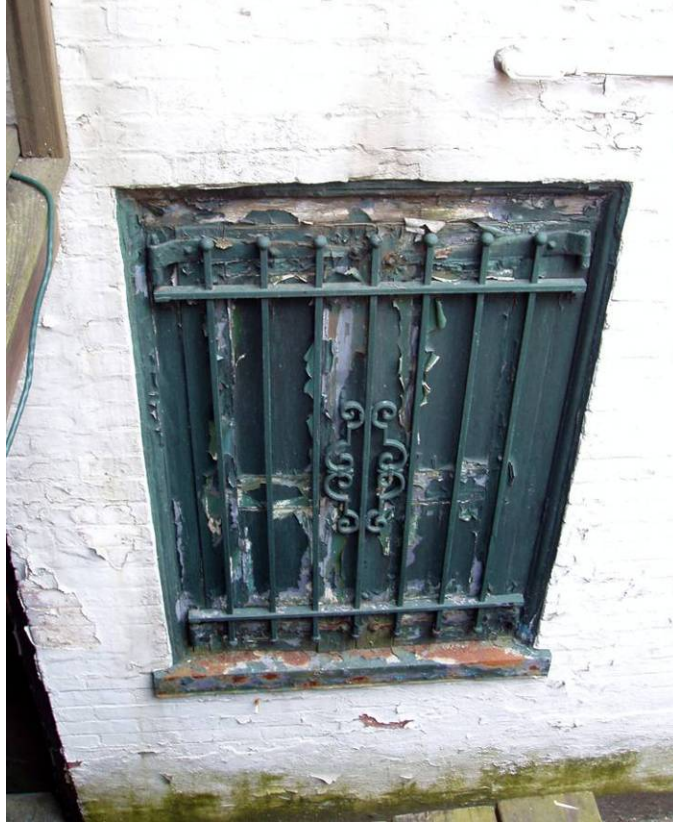
Figure B20. Rear façade, basement level passageway. Note the peeling paint and closed windows at the basement level.

3. The rear exterior of the building should be constantly monitored and maintained to ensure its proper, water-tight function. This includes the repointing of the bricks where mortar loss is found, as well as repainting whenever peeling paint can provide an entry point for moisture. Windows are especially important, as wood is much more vulnerable to decay than brick, and areas of weakness, in the form of peeling paint and rot, should be repaired in a timely manner. Not only

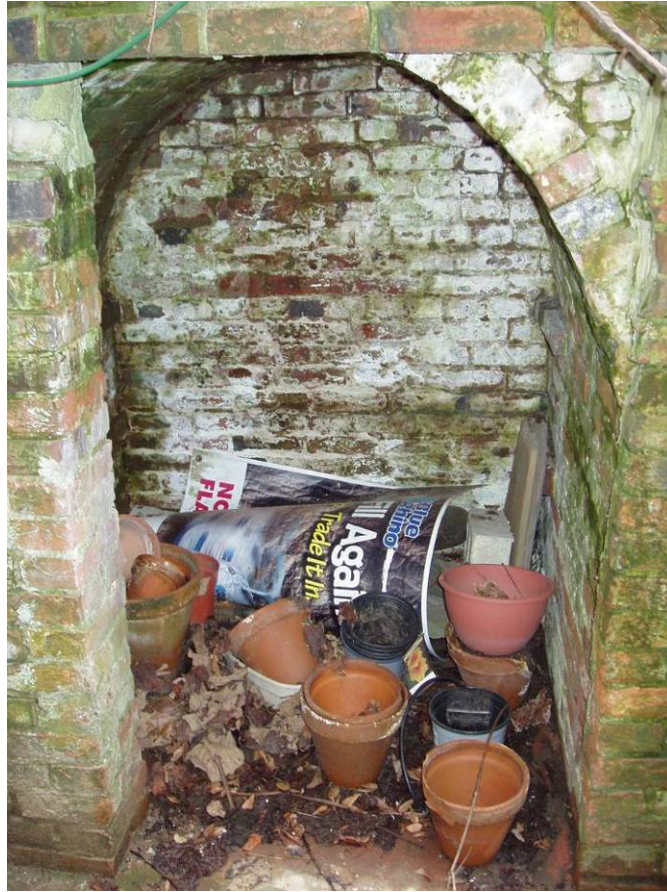
Figure B22. Rear garden retaining wall, northern vaulted storage area. Note the white staining and green biogrowth.

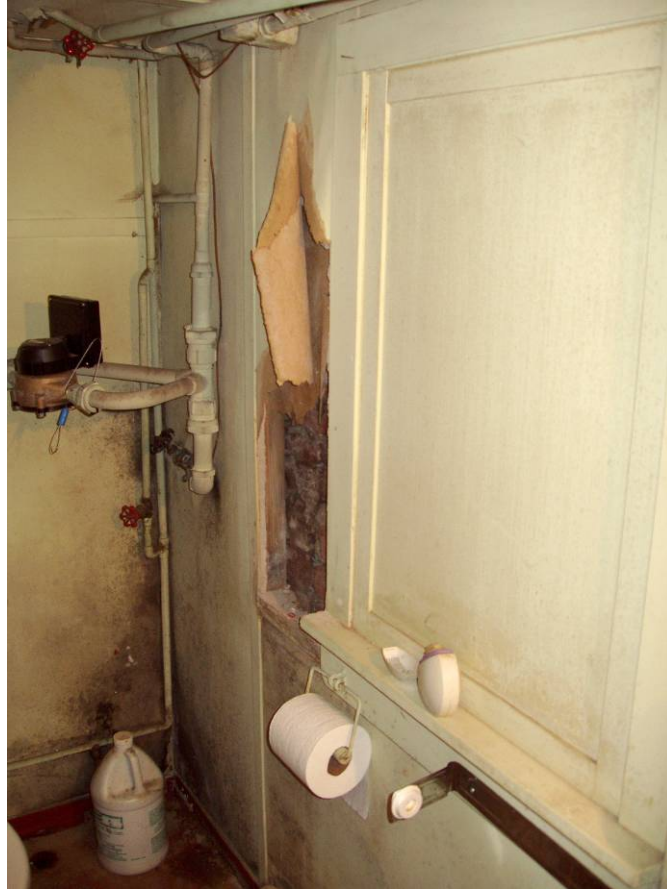
Figure B29. Basement restroom, southeast corner. Note the sever water damage on the walls.

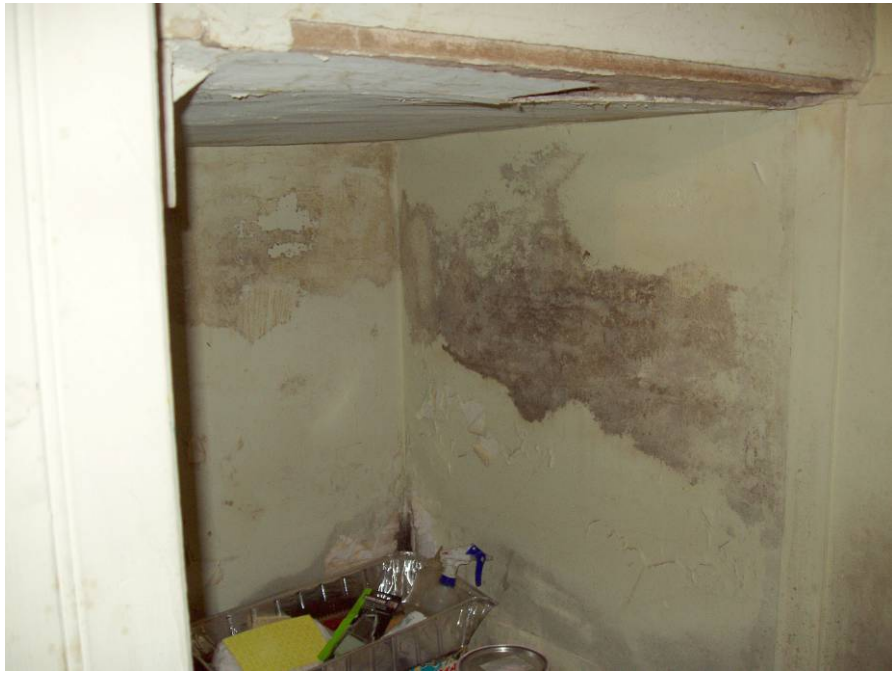
Figure B30. Basement restroom, northeast corner underneath the stairs. Note the water damage on the walls and ceiling.

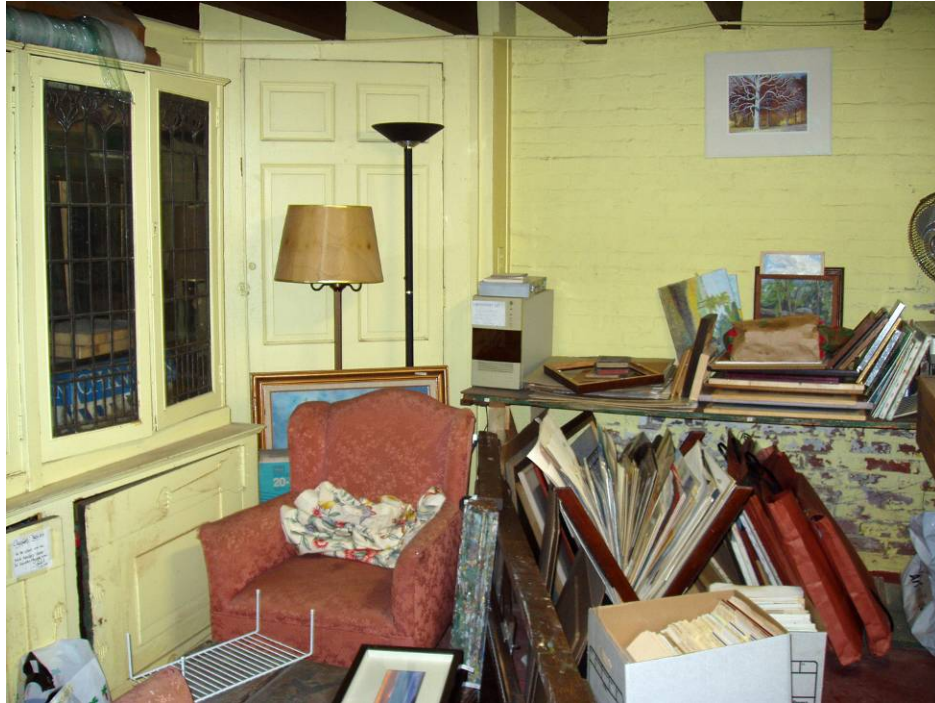
Figure B38. Basement office, former tea room, looking south. Note the water damage and peeling paint on the brick wall below the table.

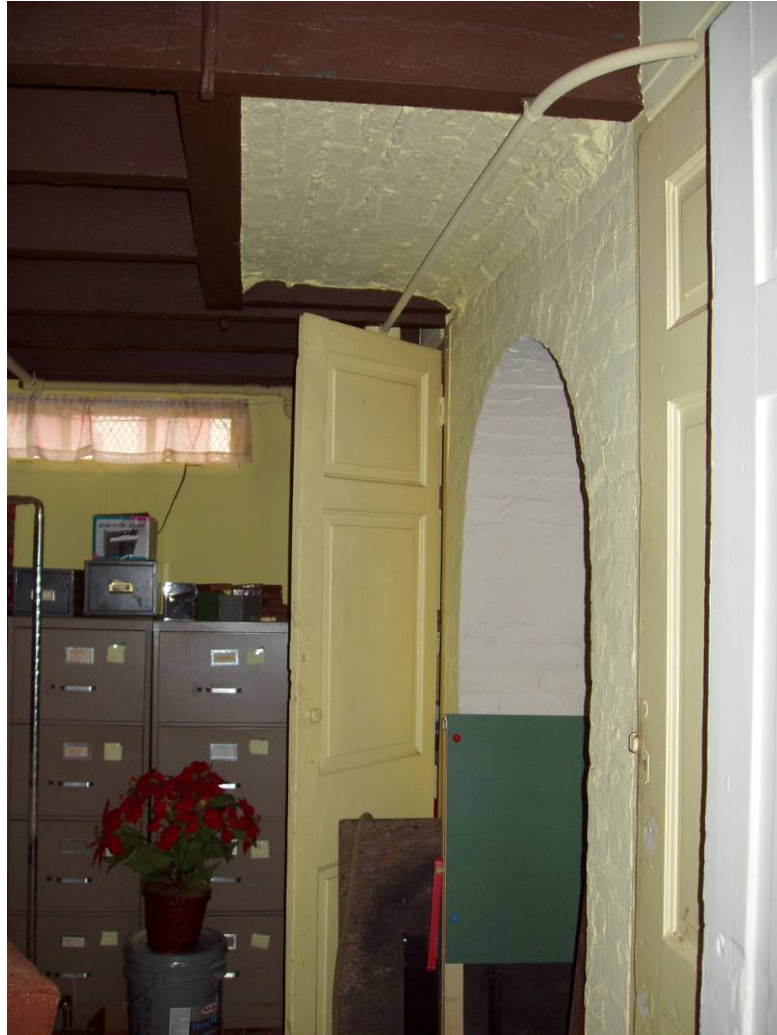
Figure B41. Basement office, former tea room, northeast corner. Note the framed brick support above the archway, indicating a support for a fireplace above. It is probable that a fireplace below this was removed for the addition of this arch.

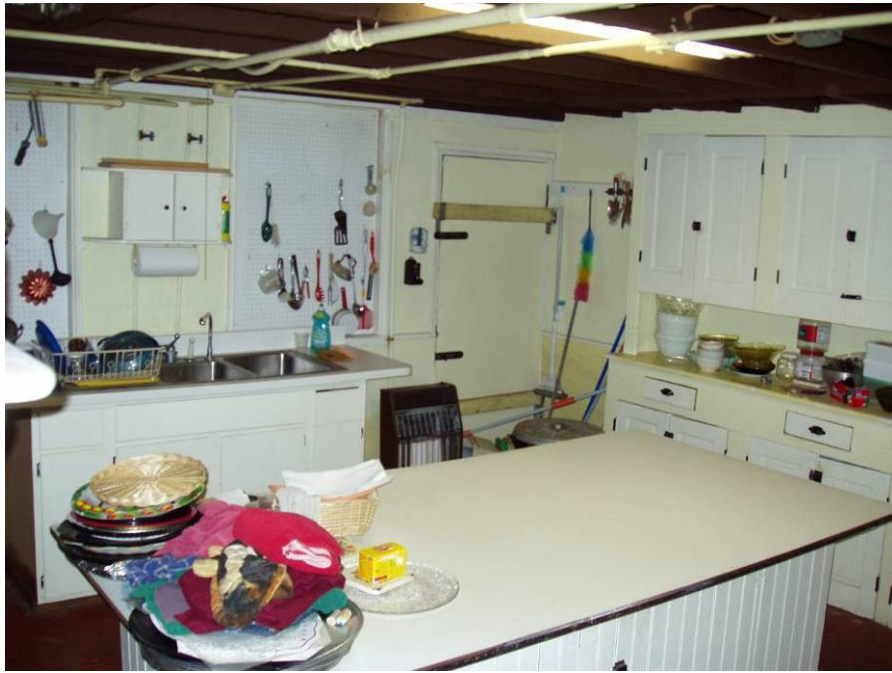
Figure B42. Basement, kitchen fireplace. Note the sheetrock patch at the lower left on the wall.

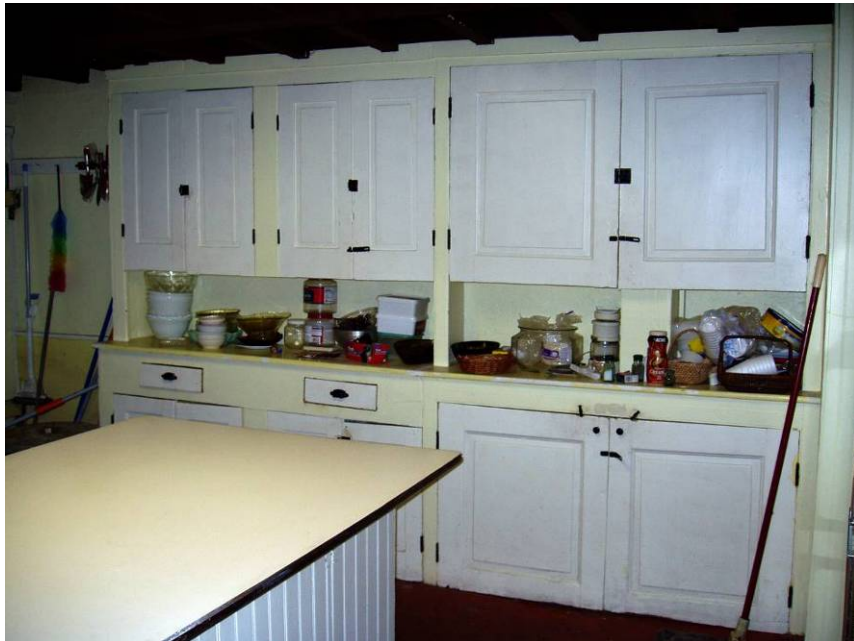
Figure B43. Basement kitchen, looking southeast. Note the pegboard covering the original windows behind the sink.

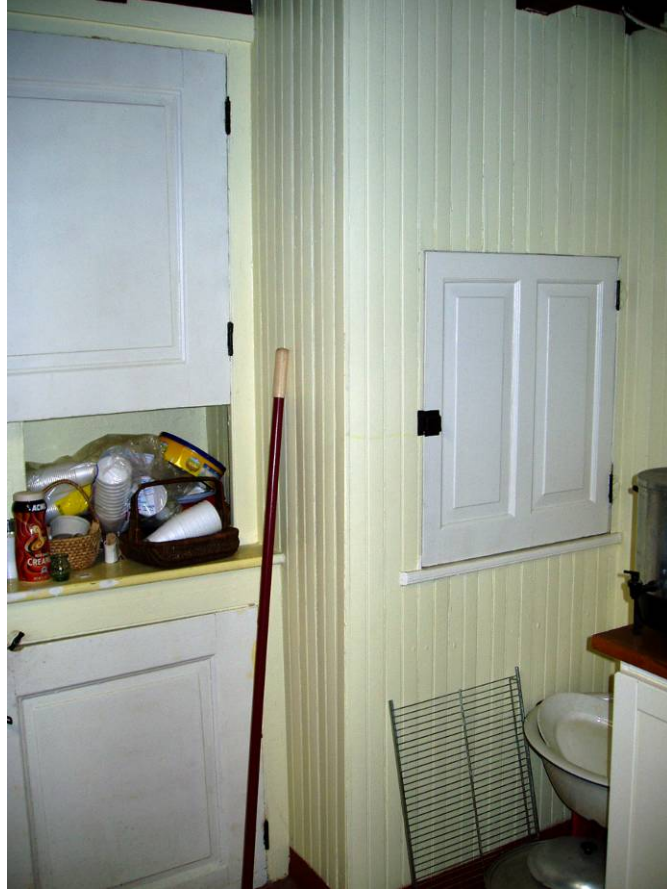
Figure B44. Basement kitchen, looking south. These cabinets were reconstructed in 1940 using the original materials.

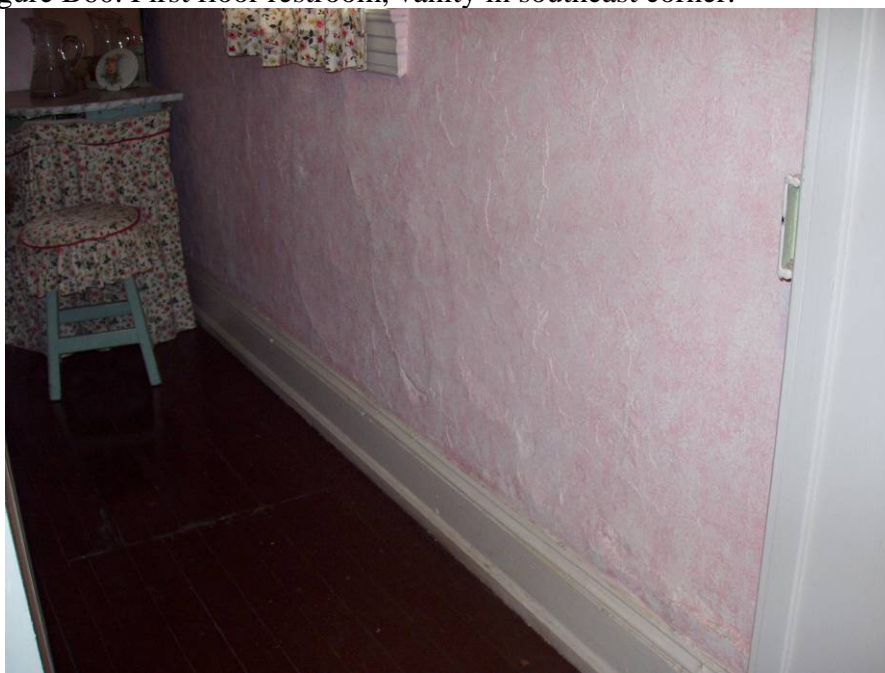
Figure B61. First floor restroom, south wall. Notice the cracks in the wall plaster.

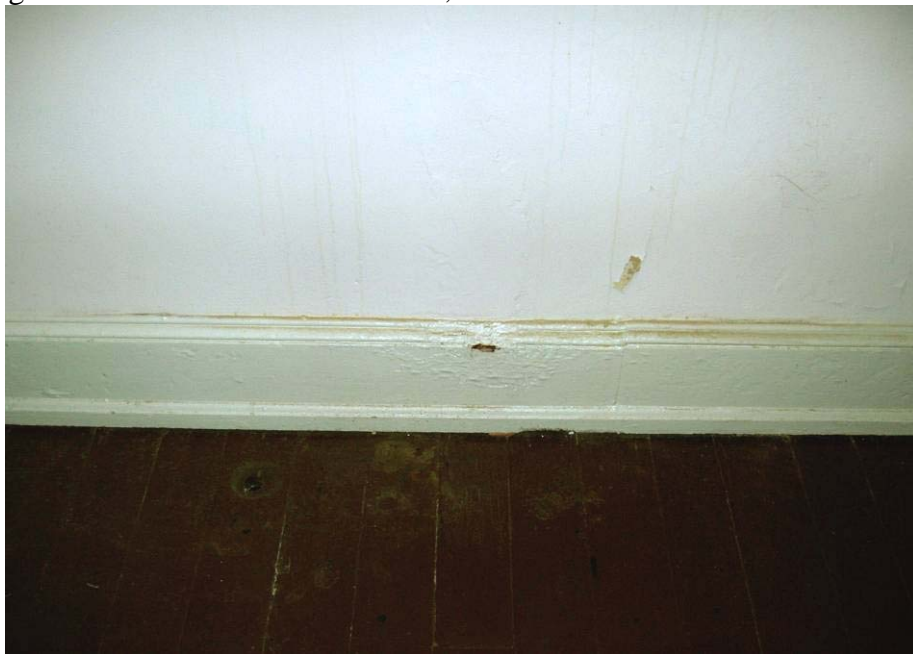
Figure B68. First floor Board Room, lower portion of the center of the west wall, showing heat damage from the original radiators.

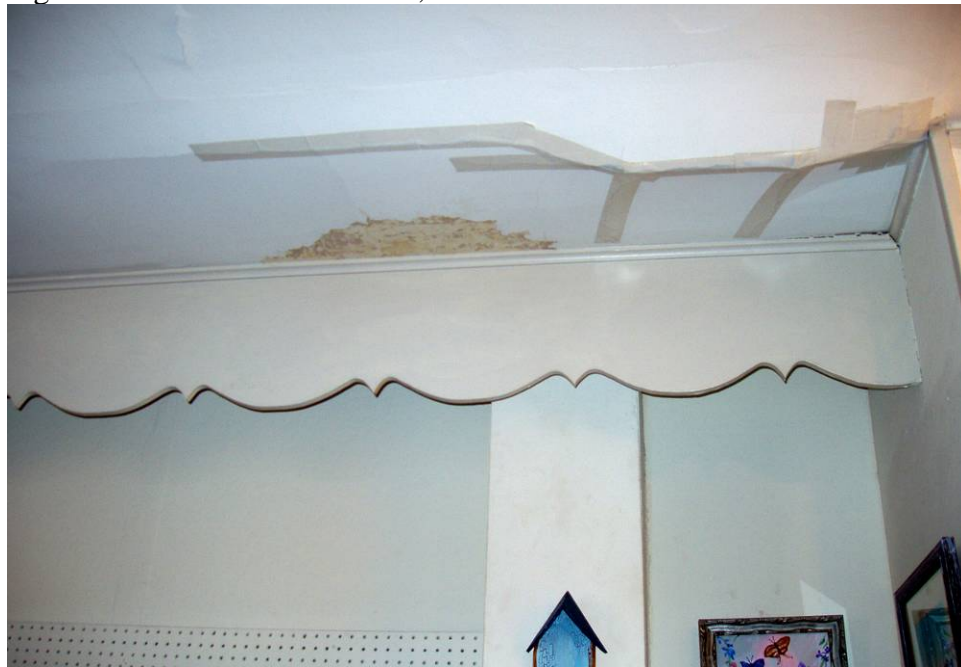
Figure B75. First floor tea room, southwest corner ceiling showing damage and fallen plaster.

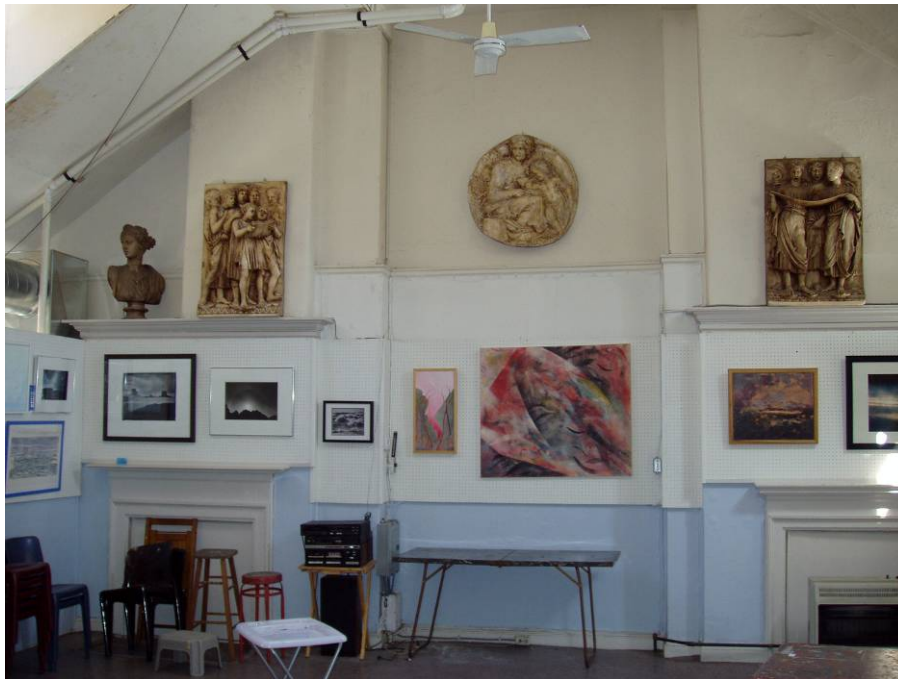
Figure B82. Second floor studio, looking southwest. Note the new aluminum duct running above the closet along the wall.

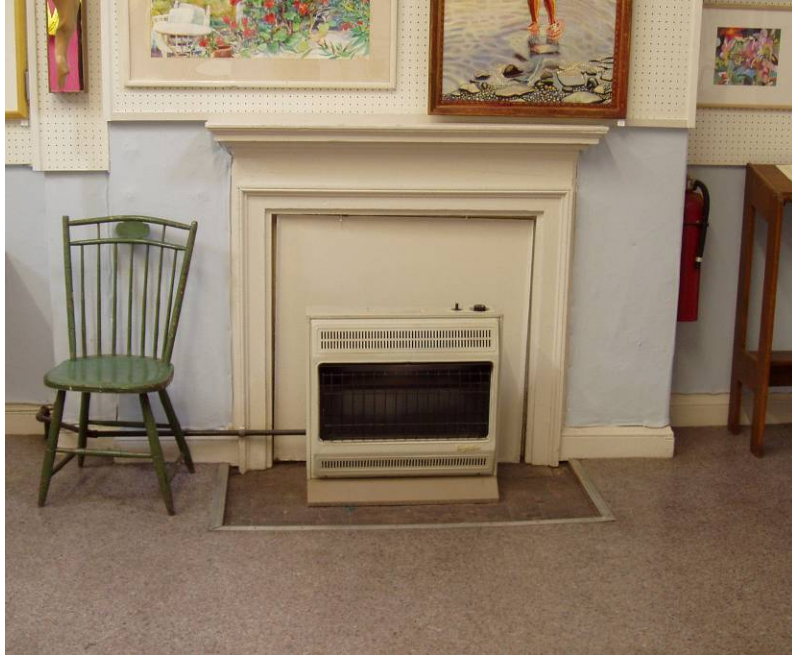
Figure B85. Second floor studio, northeast fireplace with gas-burning space heater. This unit is to be removed after the installation of the HVAC unit.

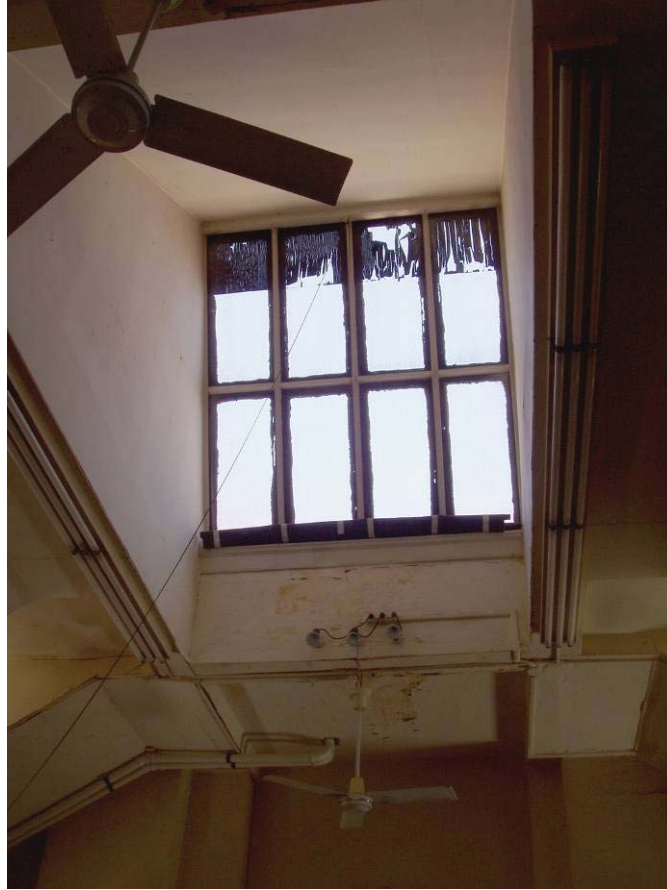
Figure B86. Second floor studio skylight. Note the blackout shade at the bottom of the window and the draw cord hanging from the top, the paint peeling from the upper portion of the window.

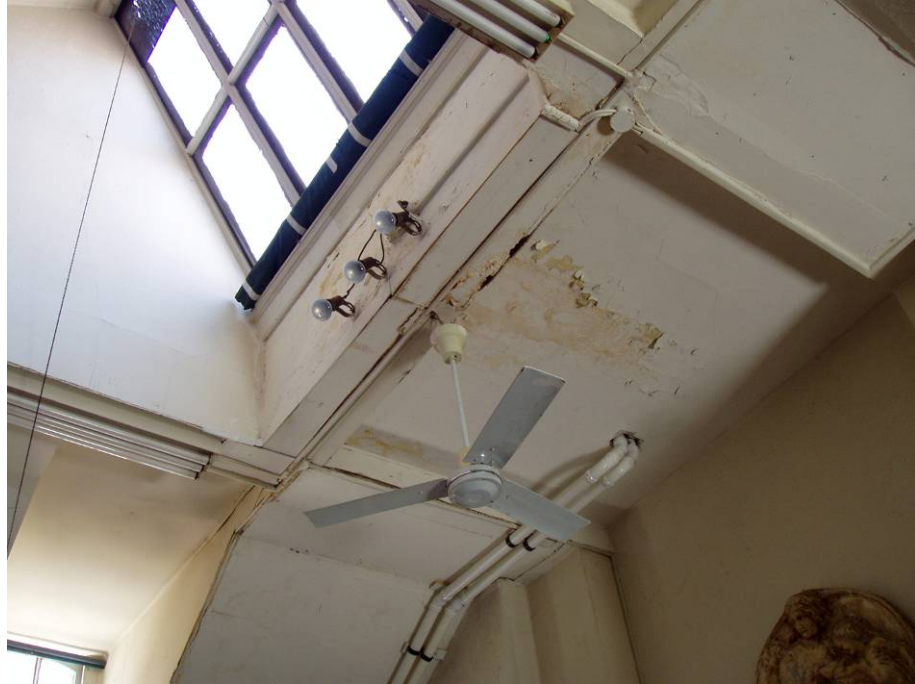
Figure B87. Second floor studio skylight, north section. Note the severe water damage in the ceiling from the leak in the skylight, also the HVAC pipes coming into the room from the ceiling.

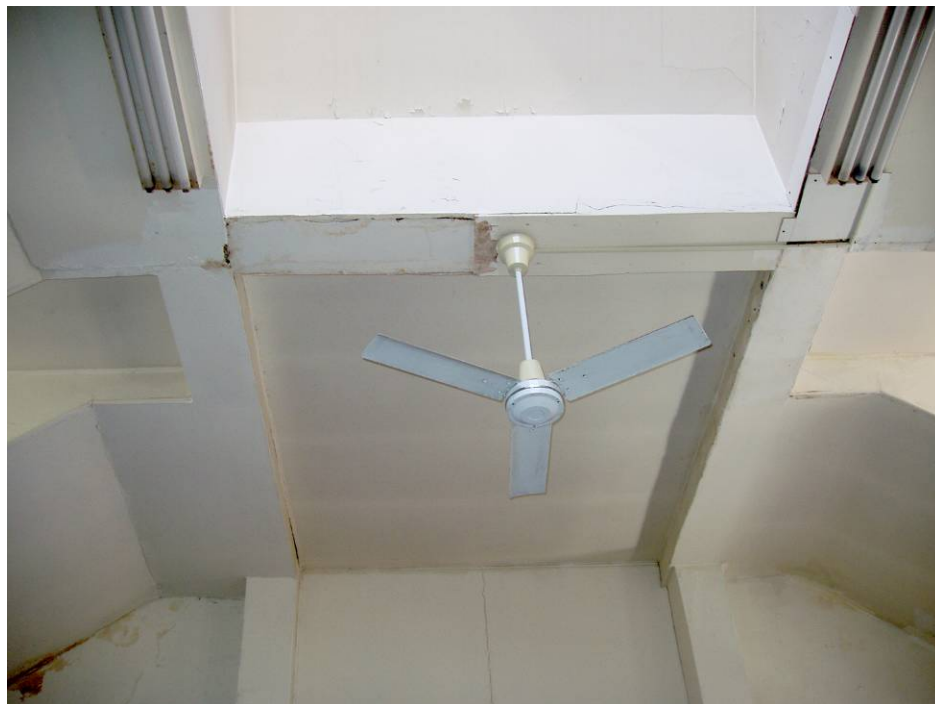
Figure B88. Second floor studio ceiling and skylight, south section. Note more water damage in the ceiling and along the top of the south wall.

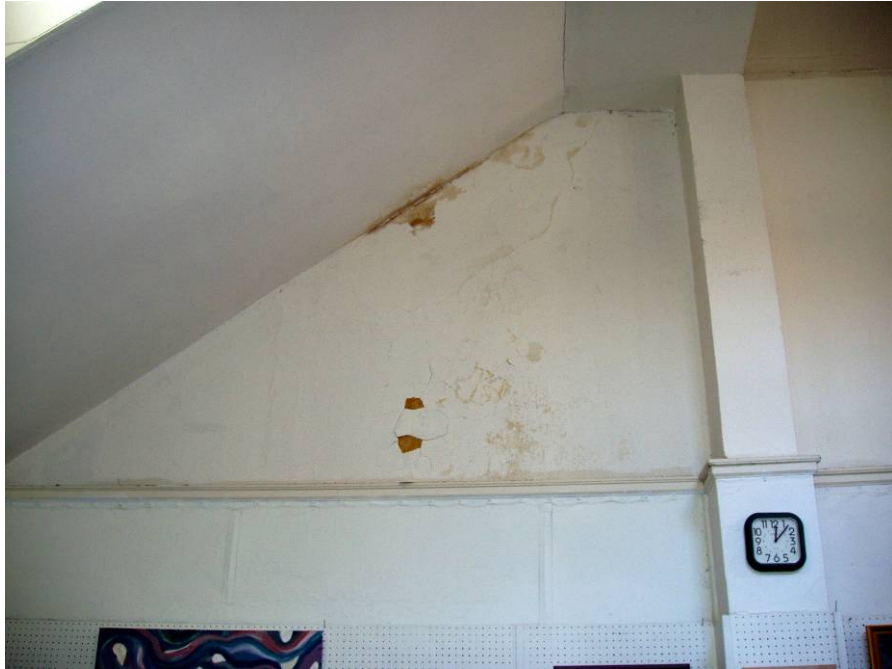
Figure B89. Second floor studio, southeast wall showing cracking and water damage.

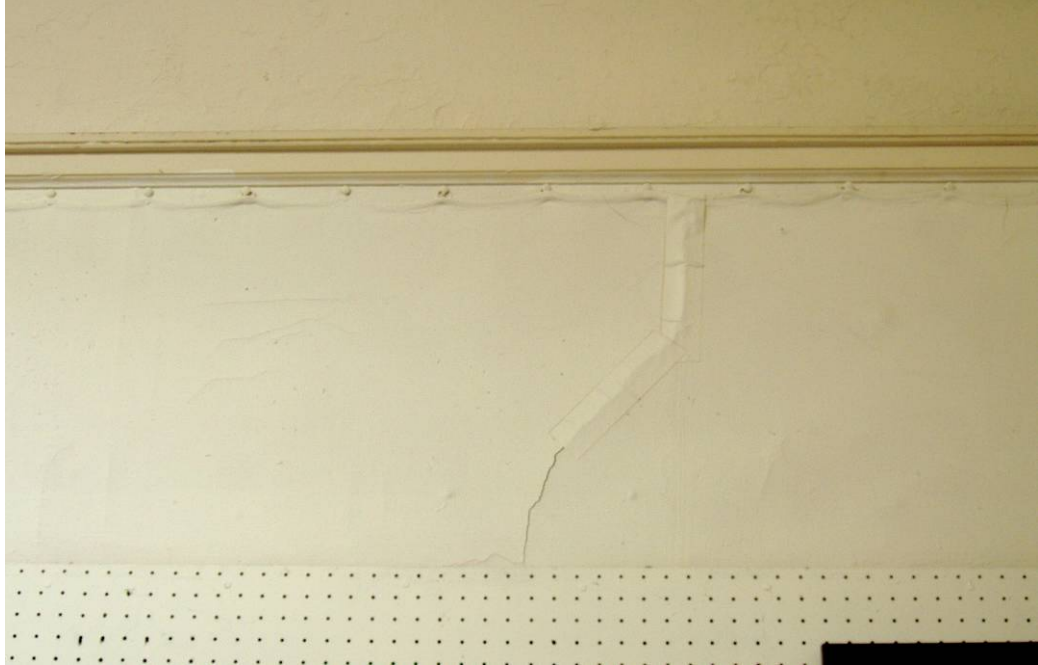
Figure B92. Second floor studio, lower portion at the eastern wall at the south, showing early monks' cloth under the layers of paint.

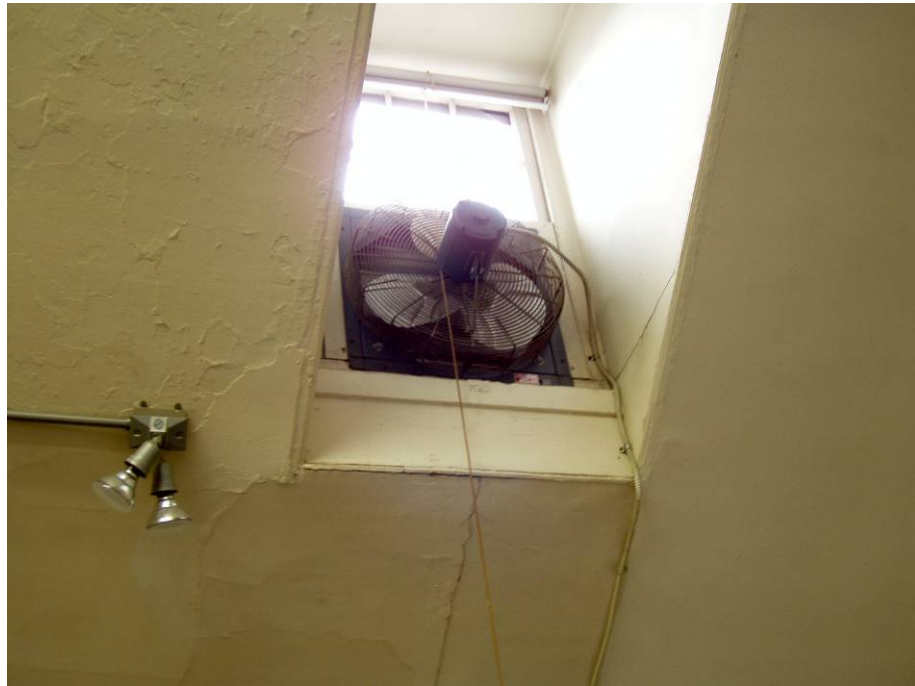
Figure B94. Second floor studio rear southern dormer window. Note the cracking and flaking in the wall plaster around the window.

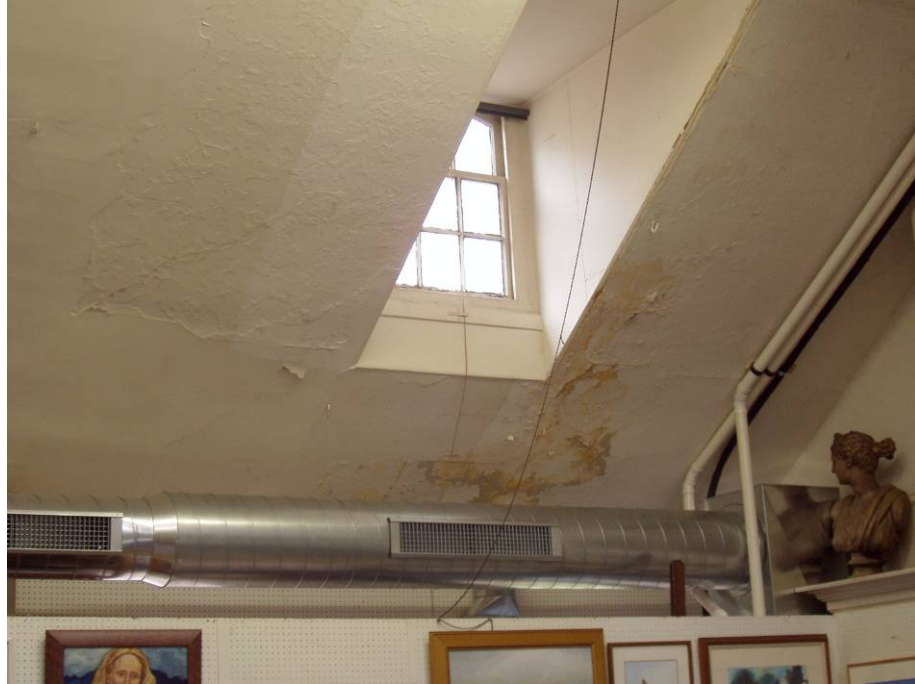
Figure B95. Second floor studio front north dormer window. Note the water damage and peeling on the plaster walls, also the piping into the HVAC unit at the right.

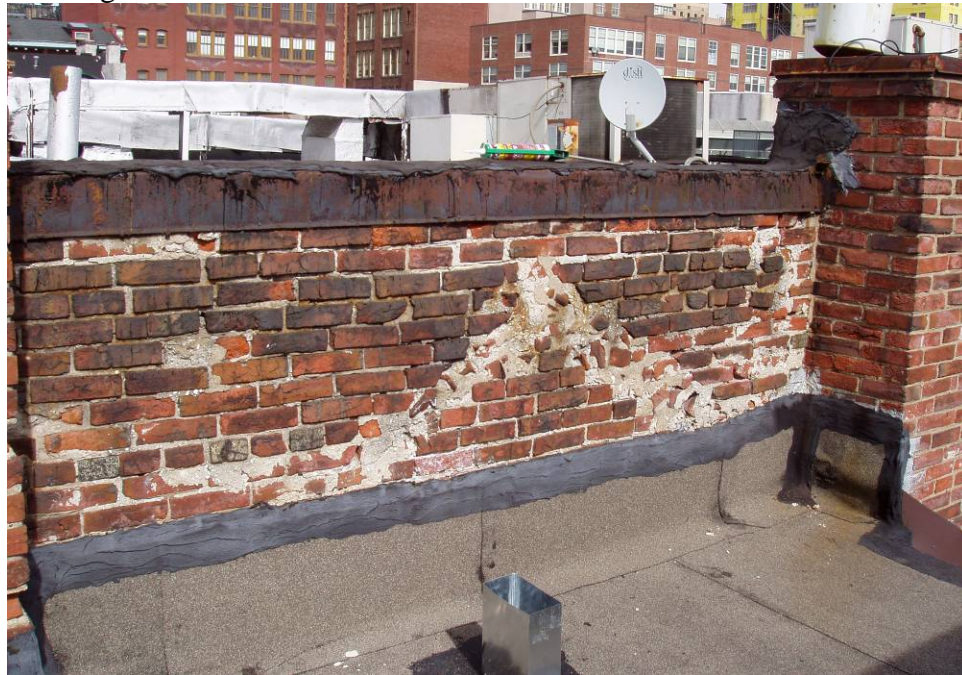
Figure B99. Roof and party wall, looking north. Note the areas on the brick wall showing mortar and brick loss.

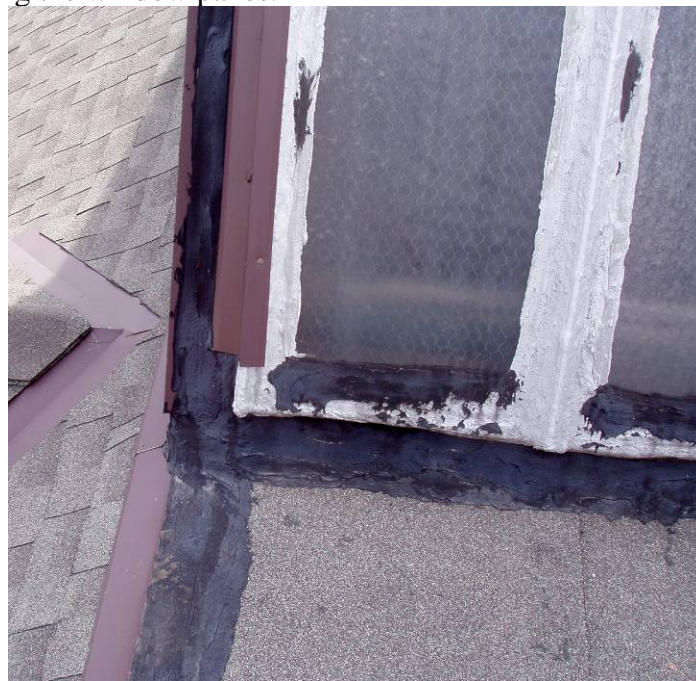
Figure B102. Skylight exterior, eastern corner. Note the buildup of tar in the attempt to fix the leak, but the flashing is incomplete.
